Impact of Chemical Aging on the Fracture Resistance of Two Ceramic Materials: Zirconia-Reinforced Lithium Silicate and Lithium Disilicate Ceramics

Mohamed S. Mohamed¹, Cherif A. Mohsen¹, Hisham katamish²

¹Department of Fixed Prosthodontics, Faculty of Dentistry, Minia University, Minia, Egypt; ²Department of Fixed Prosthodontics, Faculty of Dentistry, Cairo University, Giza, Egypt

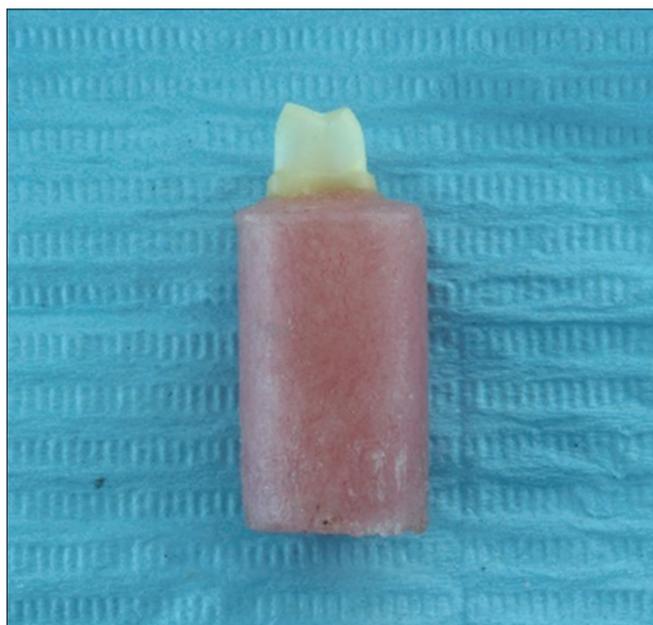
The second premolar tooth was used in this study and was prepared with a deep chamfer finish line for complete crowns. Tooth preparations were done by one operator with a total convergence angle of 10–12°, chamfer margins of 30° circumferentially, 1 mm circumferential, and occlusal reduction of 1.5 mm. All line angles were rounded (Figure 1).

Figure 1: Prepared maxillary second premolar tooth

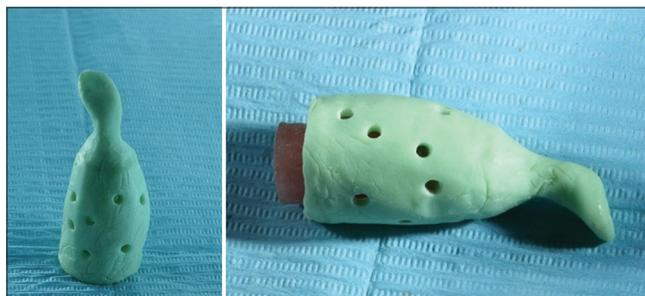
Special trays were made from acrylic resin (Figure 2) to take an impression for the model to make 40 models from the prepared tooth and the impressions

Figure 2: Acrylic special tray

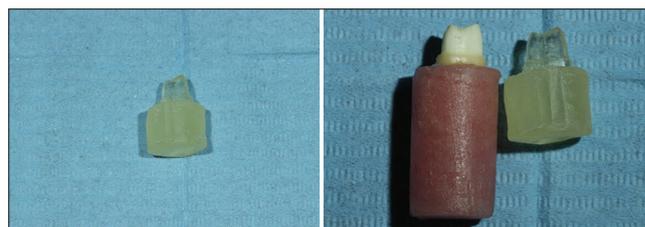
Epoxy resin (Kemapoxy 150, CMB international, Giza, Egypt) was used to pour all impressions to make the models of the prepared tooth (Figure 3).

Figure 3: Epoxy model

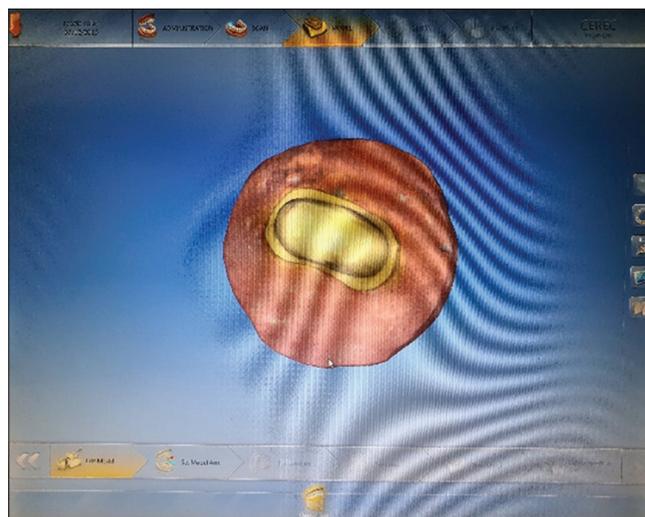
Then, the digital impression (Figure 4) was taken by CEREC Omnicom (Dentsply-Sirona, Bensheim, Germany) for the prepared tooth.

Figure 4: Digital impression

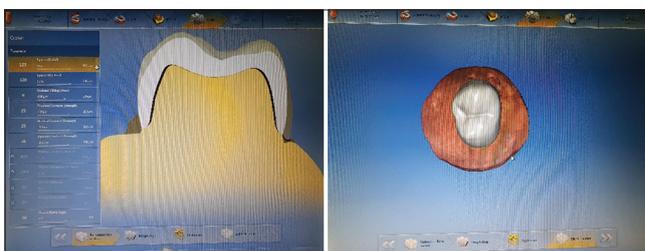
The same design of the prepared tooth made by CEREC premium software (Dentsply-Sirona, Bensheim, Germany) (Figure 5).

Figure 5: Crown designing

Both ceramics had the same parameters; spacer radial and occlusal were 120 μ, the marginal Ramp angle was 600, minimum thickness radial was 800 μ, minimum thickness occlusal was 1000 μ, margin thickness was 50 μ, and the marginal ramp width was 50 μ (Figure 5).

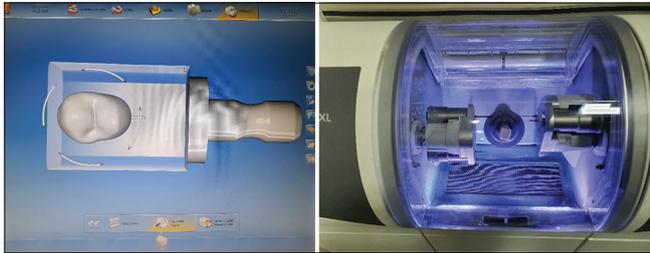
Crowns milling (Figure 6) made using CEREC MCXL (Dentsply-Sirona, Bensheim, Germany) for ceramic blocks (C14), and the sprue was placed toward the palatal surface.

Figure 6: Crowns milling

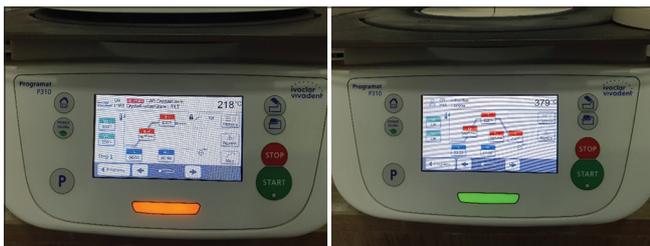
Using IPS E.MAX CAD glaze (Ivoclar Vivadent AG, Schaan, Liechtenstein, USA) and was applied to the entire crown surface using a brush and then inserted into ceramic furnace programat P310 (Ivoclar Vivadent AG, Schaan, Liechtenstein, USA) (Figure 7).

Figure 7: Crystallization and glazing

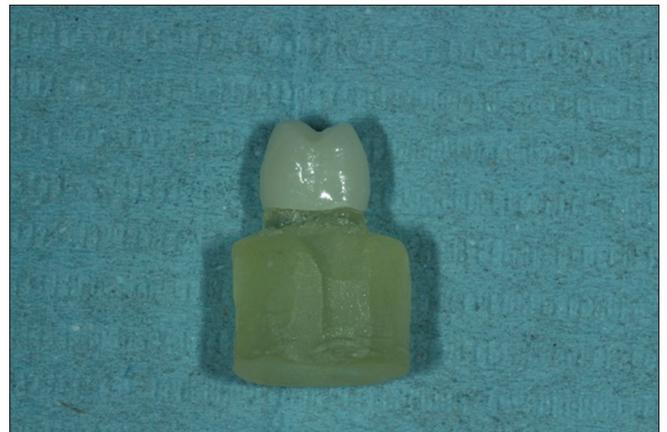
etched ceramic surface was cleaned using water spray for the 60s. A silane coupling agent (porcelain primer) (Bisco, Schaumburg, USA) was applied to the inner surface of each crown immediately and air-dried in the 60 s. Then, the ceramic crowns were cemented to epoxy teeth using the adhesive resin cement (BIS Cem) (Bisco, Schaumburg, USA). The excess cement at the margin was removed carefully, and an air-inhibiting gel was applied. The composite resin cement was lightly cured Blue N phase (Ivoclar Vivadent AG, Schaan, Liechtenstein, USA) for the 30 s on each side with a light intensity of 1200 mW/cm² (Figure 8).

Figure 8: Cemented crown

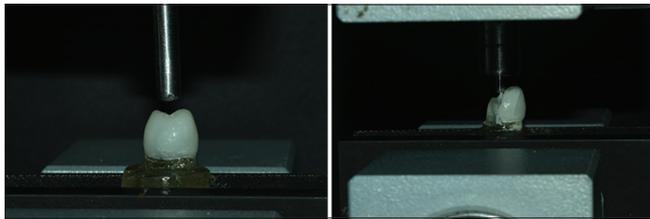
Then, the samples were placed in a universal test machine (Instron) for the fracture resistance test. A stainless-steel ball 3 mm diameter was used to apply a compressive load on the occlusal surface along the long axis of the tooth at a crosshead speed of 1 mm min. This compressive load was centered on the midline at the central fossa of each crown (Figure 9). A piece of polyethylene foil, with 1 mm thickness, was placed between the crown and the ball to achieve a uniform

Figure 9: Fracture resistance test

distribution of the force [8]. The maximum load at which the specimens fractured was recorded in Newton's.

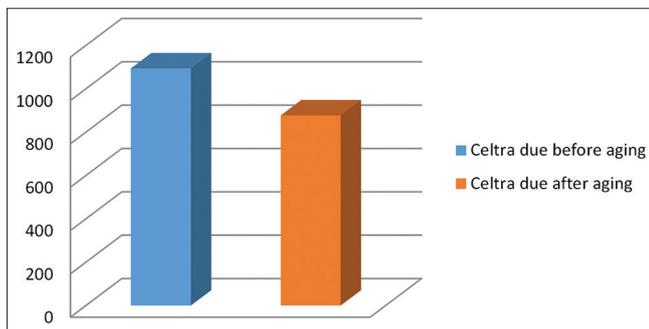
is a statistically significant difference between the two groups. ZLS before aging recorded higher fracture resistance (1093.96 N) than ZLS after aging (877.07N) (Figure 10).

Figure 10: A comparison between fracture resistances of zirconia-reinforced lithium silicates without and with aging

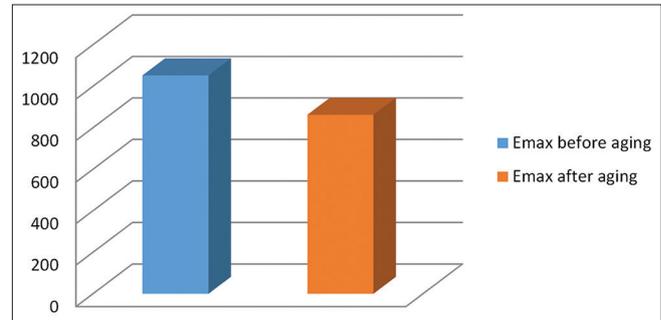
Means and standard deviations of the fracture resistance of the lithium disilicate before aging and lithium disilicate after aging are shown in the Table 4. The results showed that there is a statistically significant difference between the two groups. Lithium disilicate before aging recorded higher fracture resistance (1052.16 N) than after aging (862.7N) (Figure 11).

Figure 11: A comparison between fracture resistances of lithium disilicate without and with aging

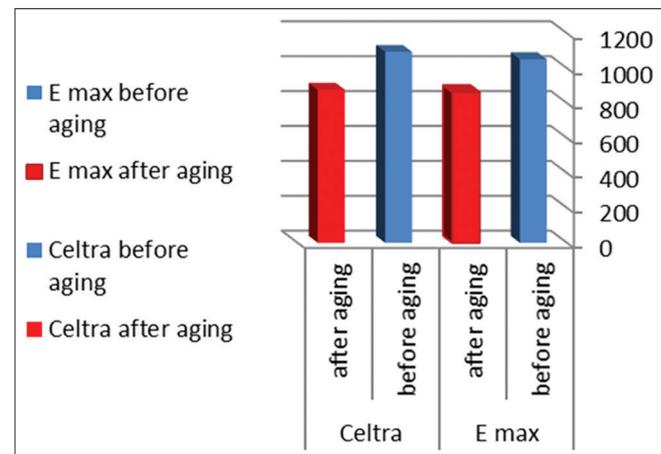
Figure 12 showed a comparison between the two tested ceramics before and after aging, although that ZLS recorded higher fracture resistance than lithium disilicate before and after aging (1093.96# 1052.16) and (877.07# 862.7), there was no statistically significant difference between these two ceramics.

Figure 12: A comparison between fracture resistances of all groups
